# Manhole Inspection Summary

Manhole # S67M\_\_009MH

Insp Date: **1/23/08 9:53 AM**

**Location** Address: **6500 O'Donnell St.**

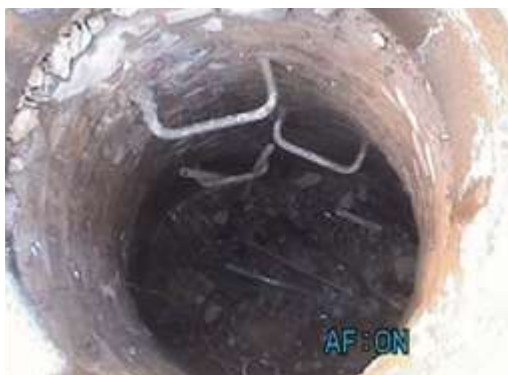
Defect 1

**Frame** Offset: **1** (in.) Condition: ☒ Sound ☐ Cracked ☐ Leaks

Condition: ☐ Sound ☒ **Cracked** ☐ Root Intrusion ☒ **Loose Brick** ☒ **Deteriorated**

1in. frame offset. Loose bricks around frame.

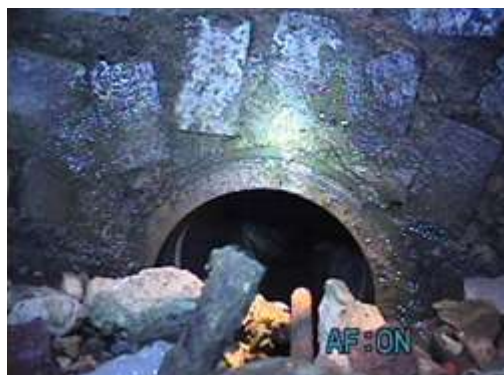
Defect 4

[dsgr] deposits settled gravel and rocks in front of the 12 o'clock outgoing pipe connection

Comments **MANHOLE IS FILLED WITH DEBRIS. CLEANING REQUIRED. ICE AROUND MANHOLE IS EVIDENCE OF SHEETING.**

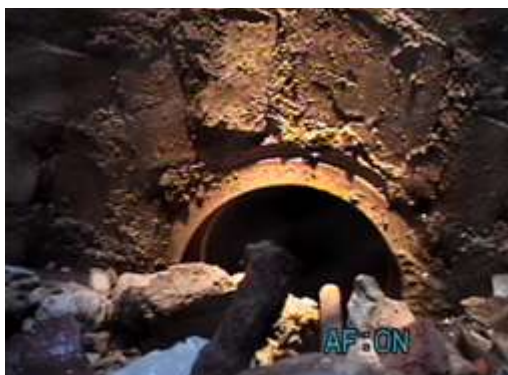
Defect 3

Condition: ☐ Sound ☐ Cracked ☐ Root Intrusion ☐ Deteriorated ☐ Leaks ☒ **Debris**

[dsgr] deposits settled gravel and rocks in the channel

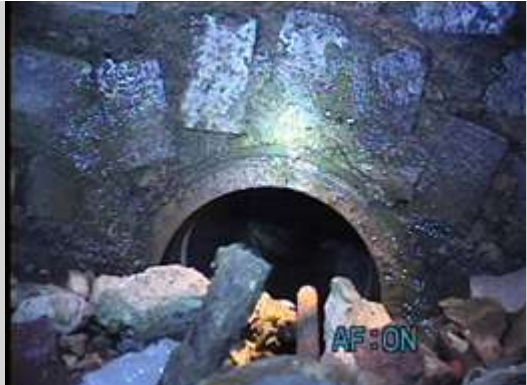
12 O'Clock Outflow

Deposits: ☐ None ☒ **Mud** ☐ Sludge ☐ Debris ☐ Grease

Silt Depth: **0.25** (in.) Deposits Extent: **Heavy**
